New York State Department of Transportation

Yellow Flag NB22CTW027

BIN: 1065318

Location: Span 240, Stringer S2 at Pier 240

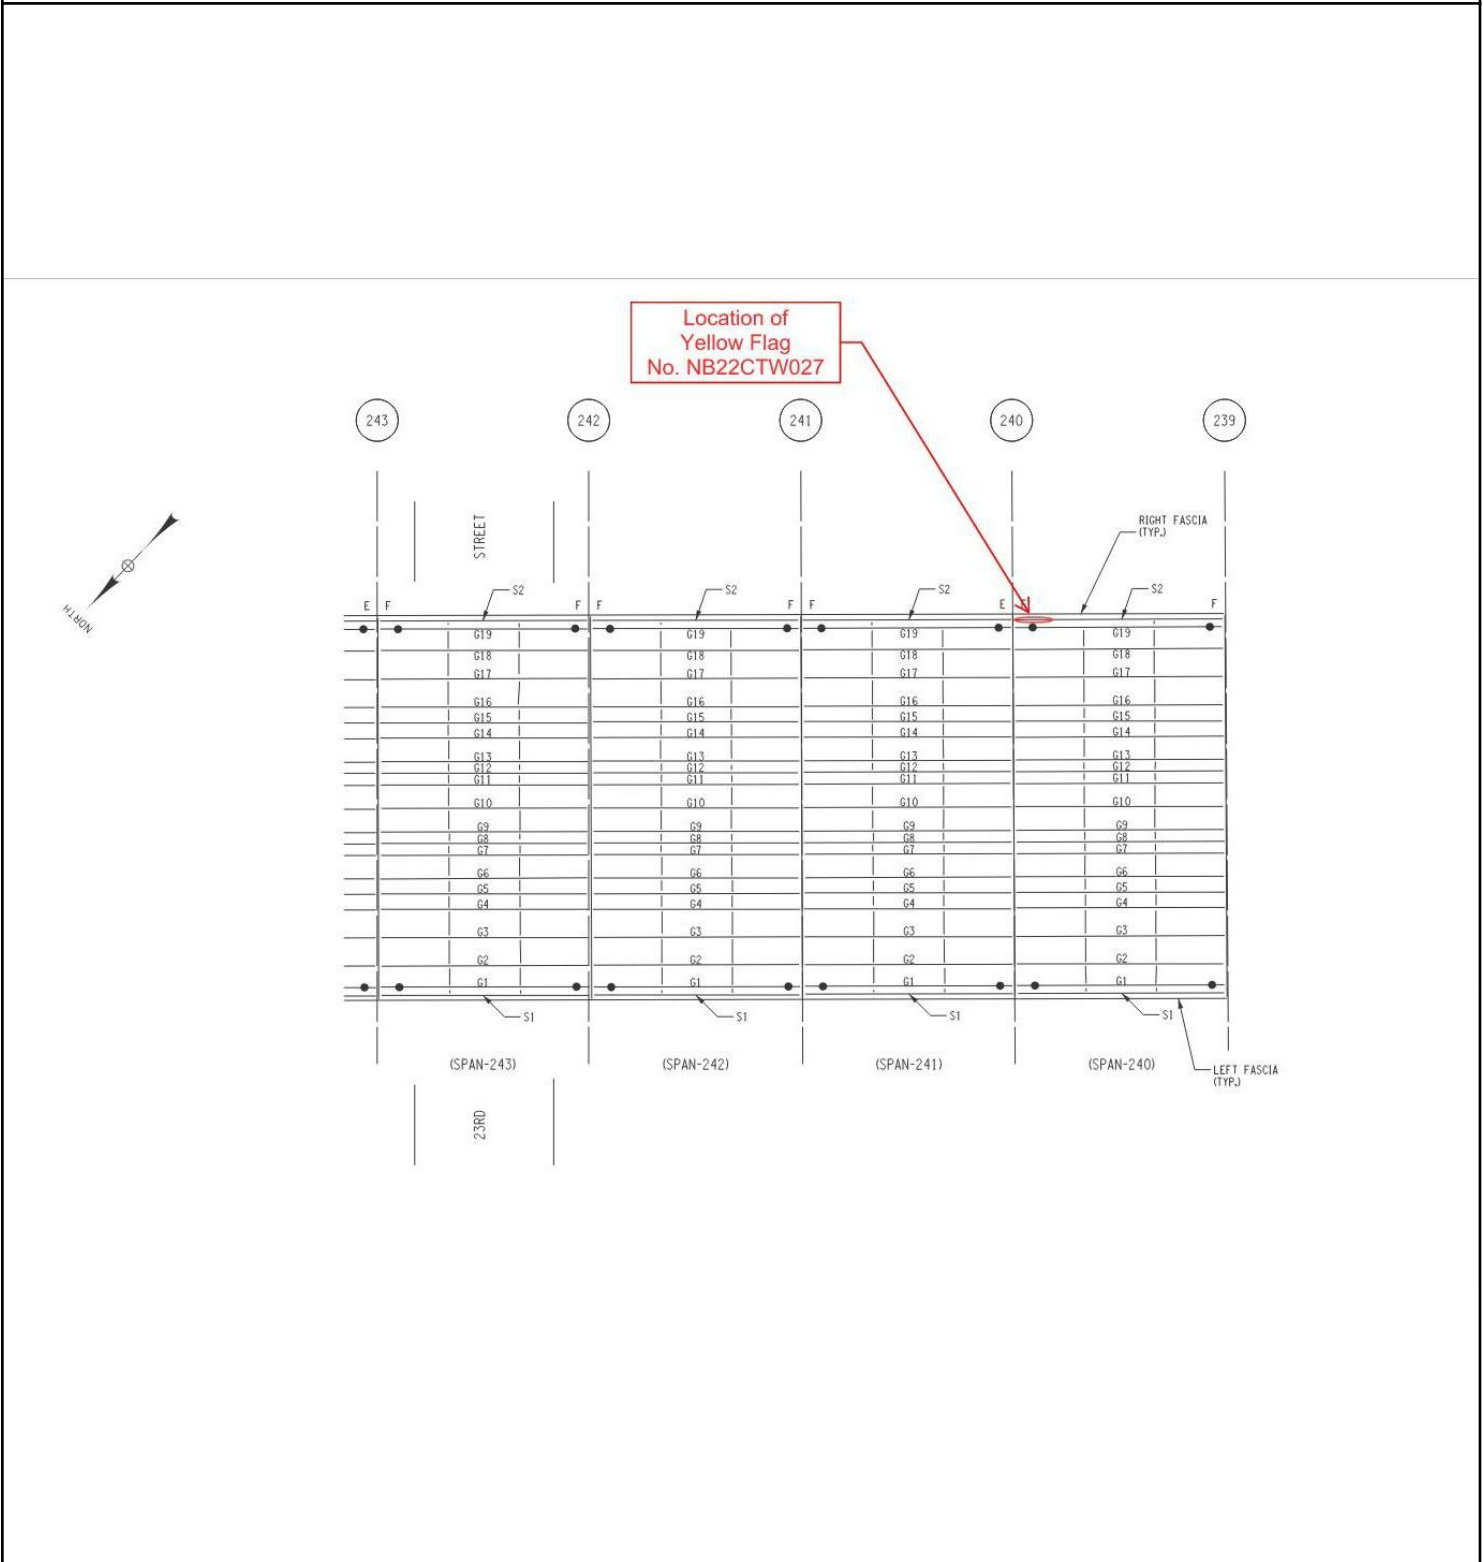
Photo Number: 1

Attachment Description: Framing Plan - Span 240

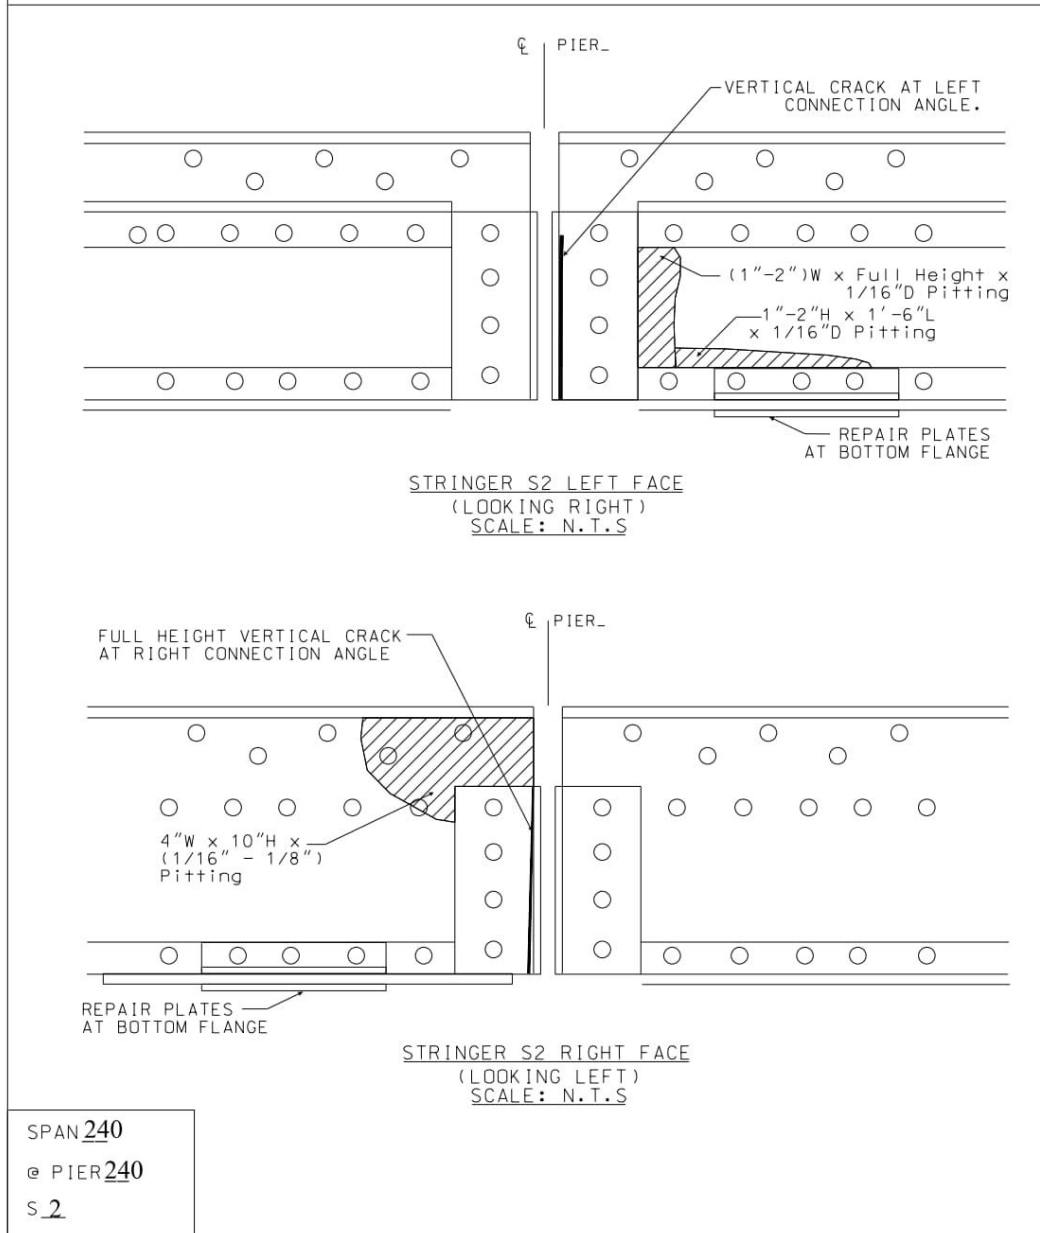
Photo Number: 2

**Attachment Description: Yellow Flag Condition Sketch**

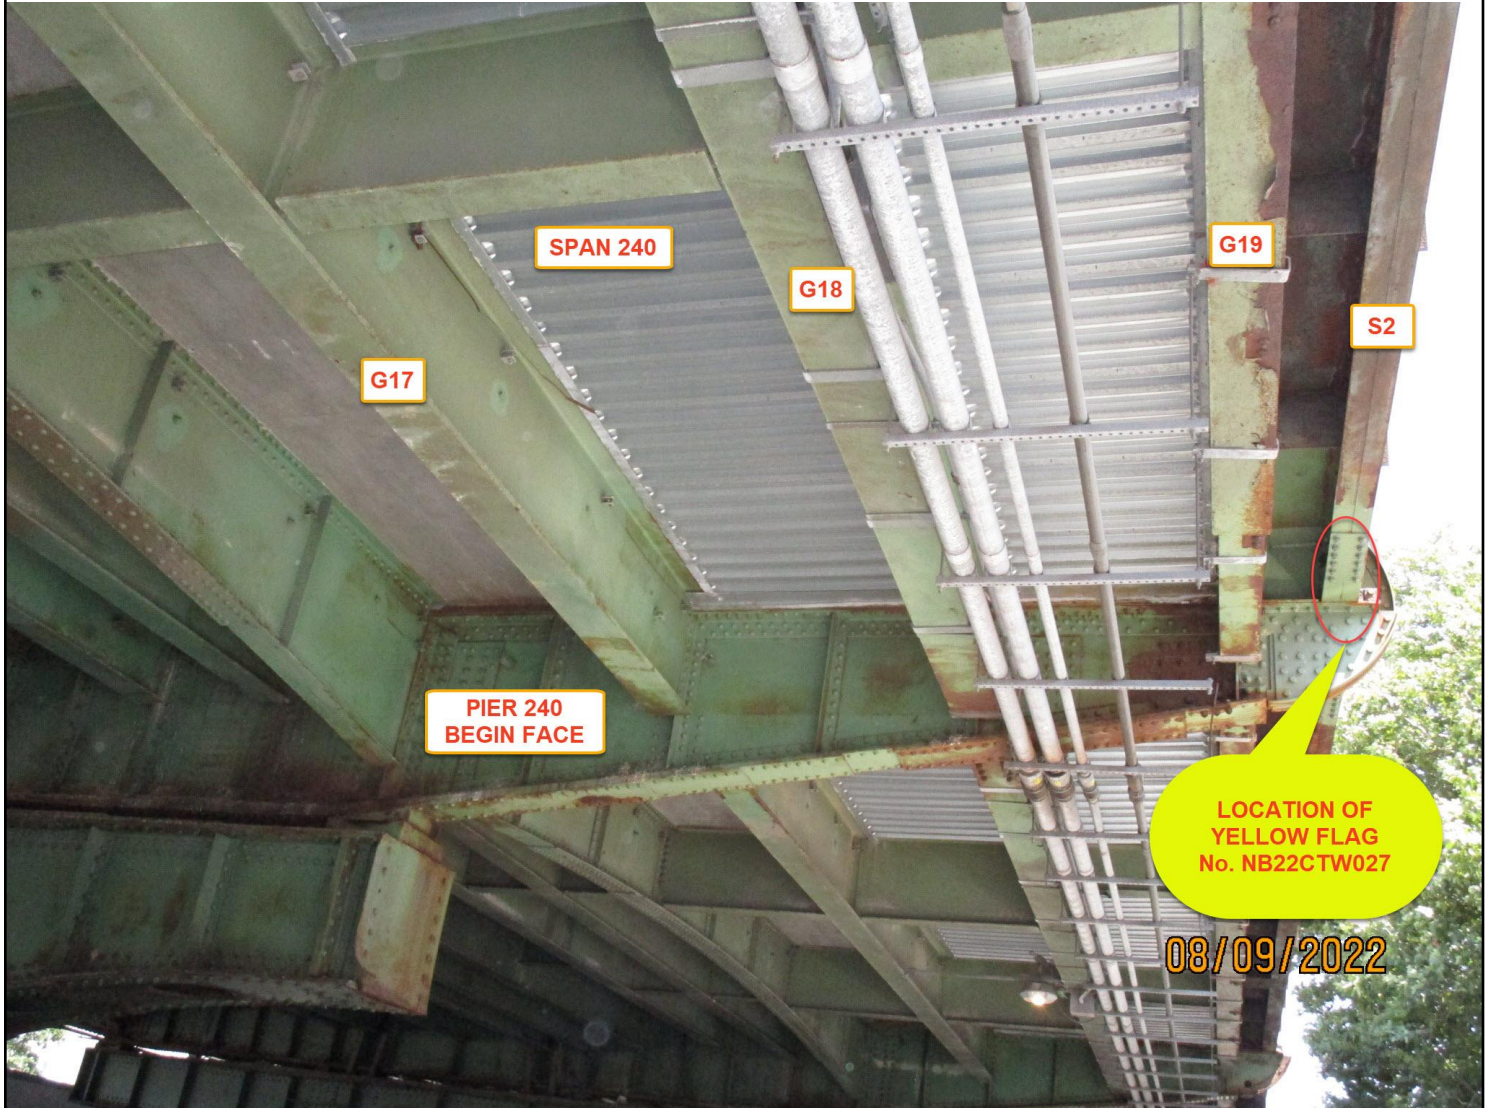
Photo Number: 3

Attachment Description: General view of the flagged condition at Span 240 Stringer S2 at Pier 240. Looking End.

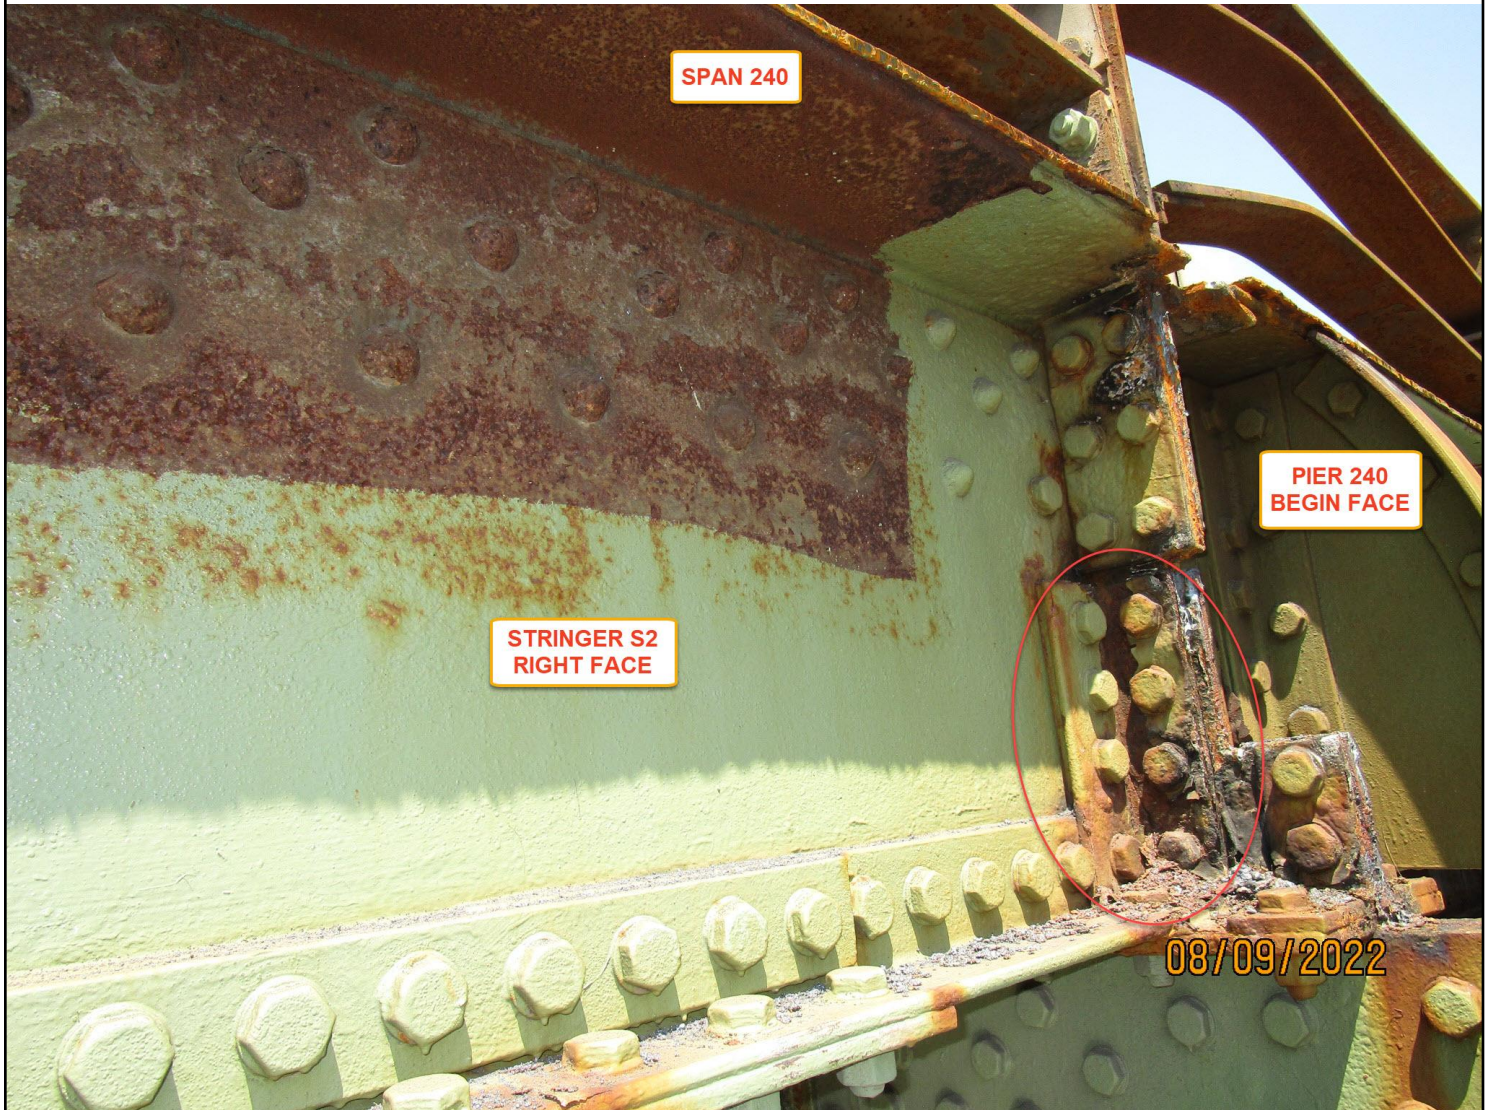
Photo Number: 4

Attachment Description: Close up general view of the right side of Stringer S2 at Pier 240. Looking End Left.

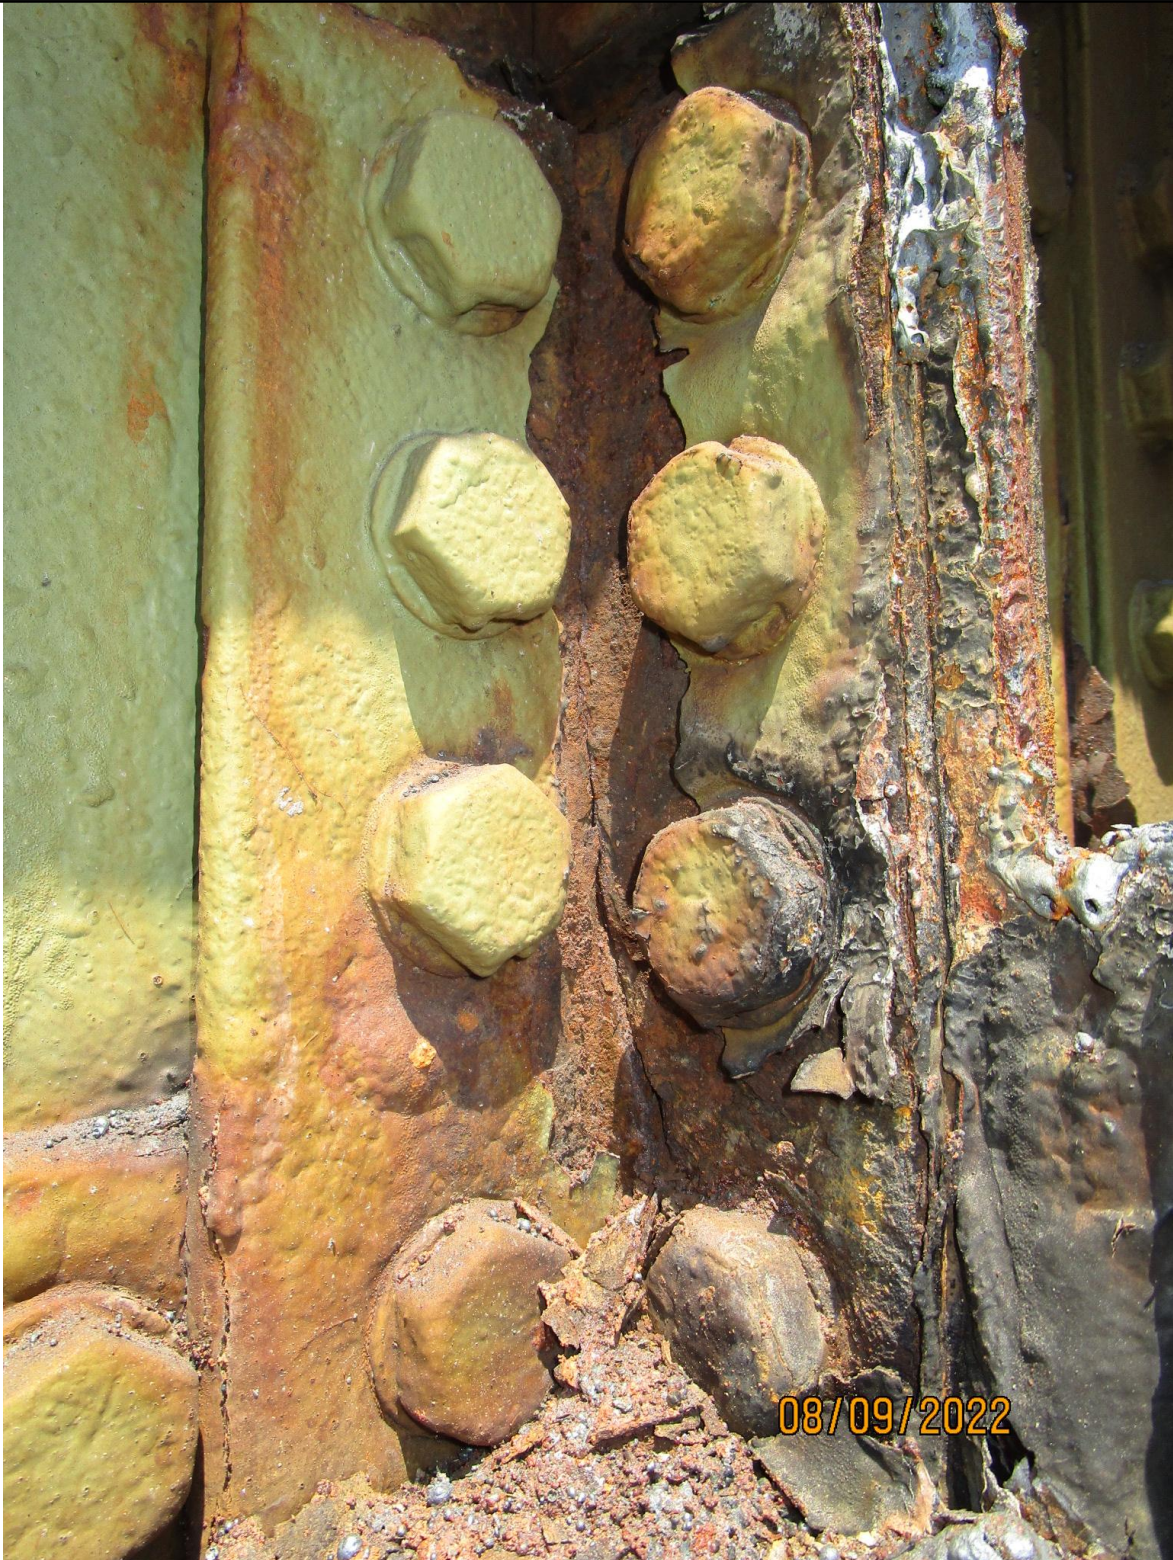
Photo Number: 5

Description: The right side connection angle at Stringer S2, Pier 240 exhibits a full height vertical crack (photo 5). In addition, the left side connection angle exhibits a vertical crack which extends from the bottom of the connection angle to 2" from the top (photo 7).

Attachment Description: Close up view of the right side of Stringer S2 at Pier 240. The right side connection angle at Stringer S2, Pier 240 exhibits a full height vertical crack at the angle fillet. Looking End Left.

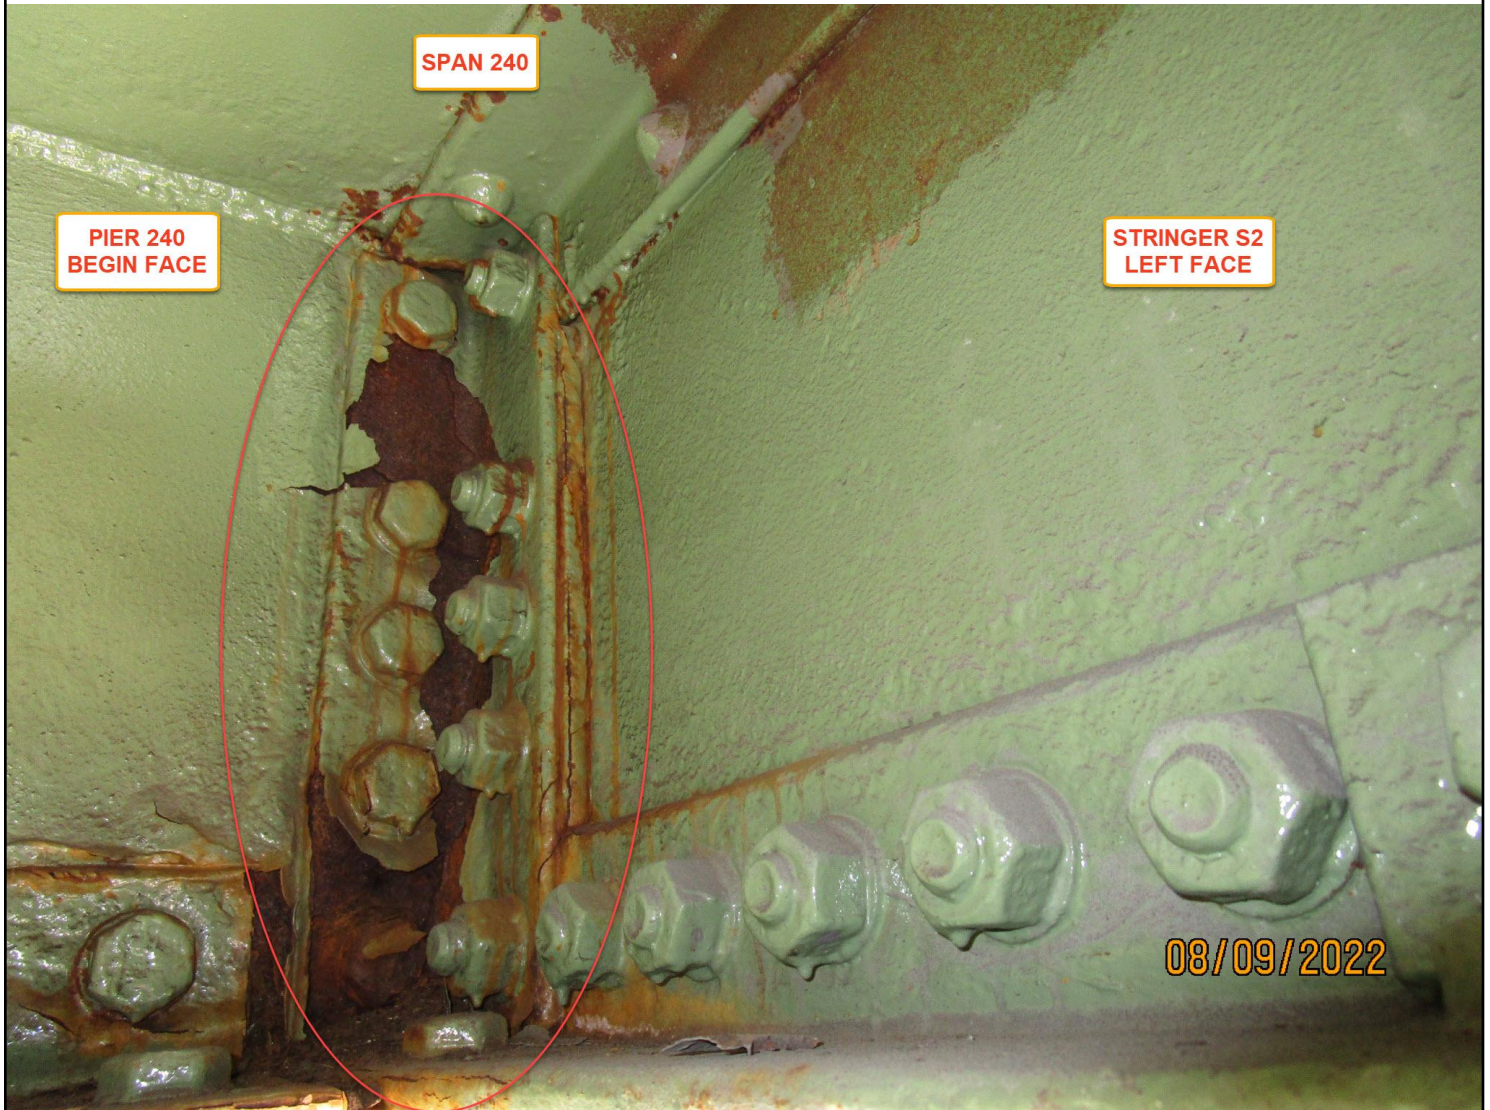
Photo Number: 6

Attachment Description: Close up general view of the left side of Stringer S2 at Pier 240. Looking End Right.

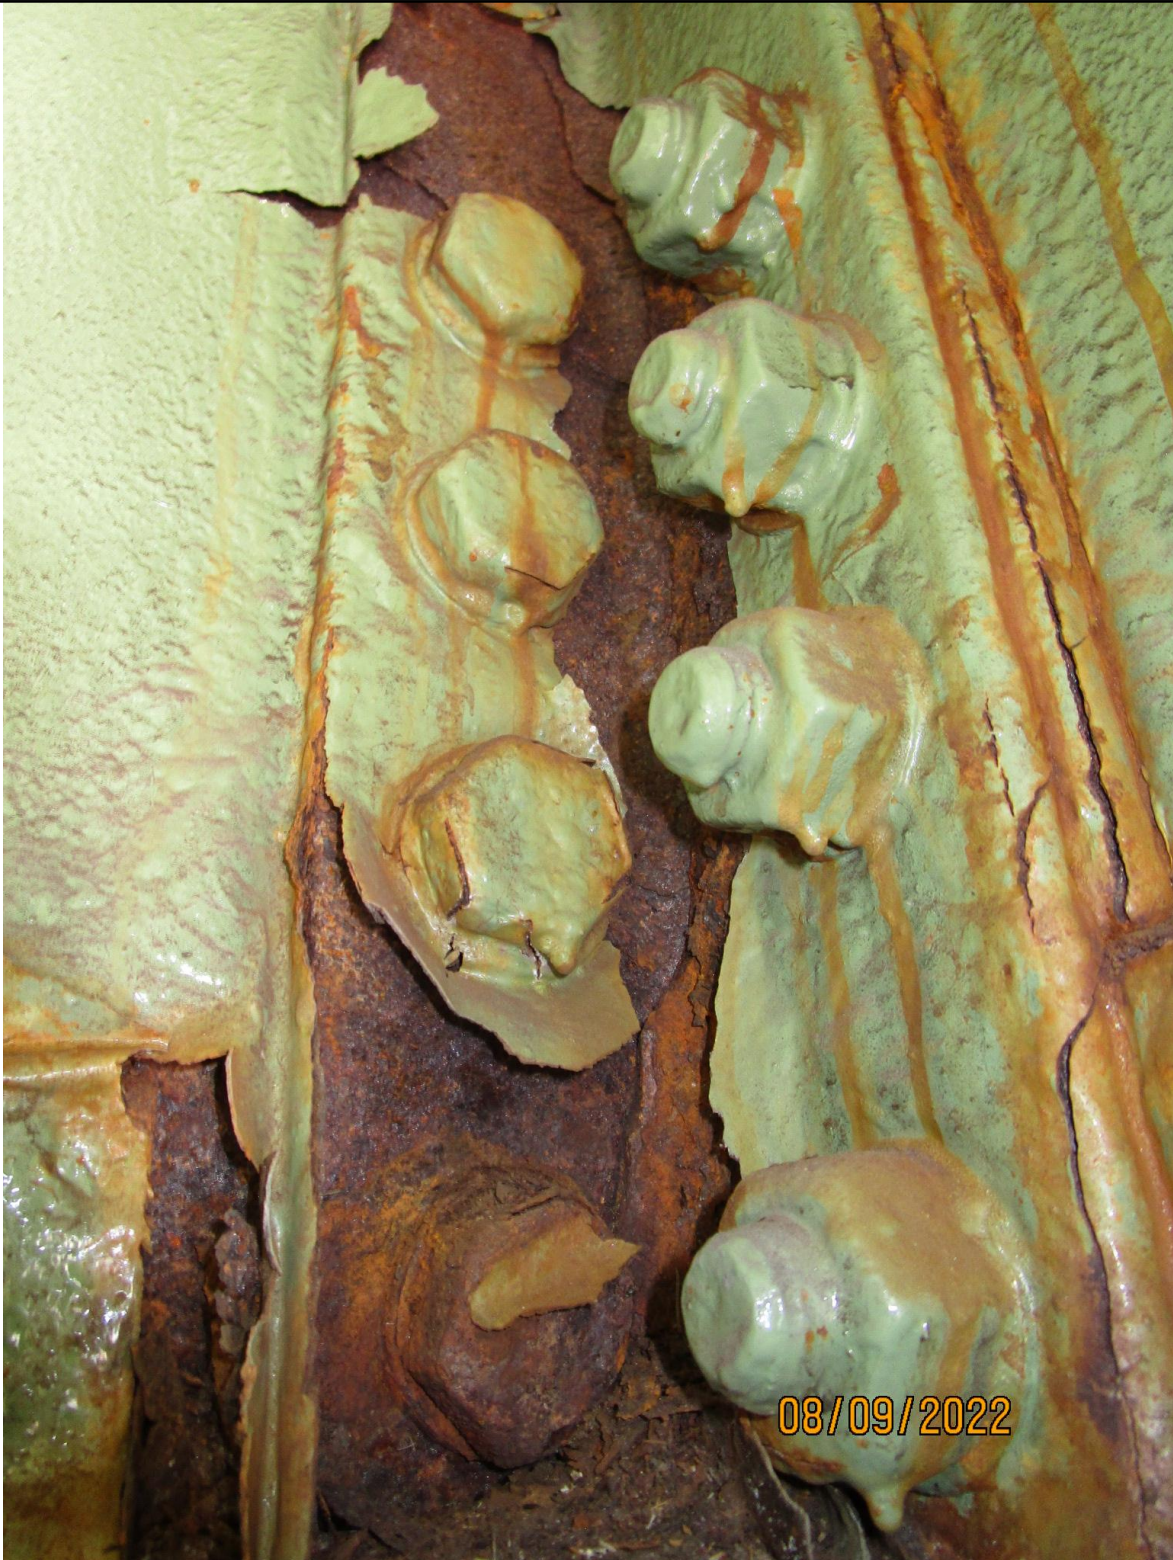
Photo Number: 7

Attachment Description: Close up view of the left side of Stringer S2 at Pier 240. The left side connection angle exhibits a vertical crack which extends from the bottom of the connection angle to 2" from the top. Looking End Right.
